**RESTORATION
COMMENDED**

**Little Gaddesden
Lodge
Berkhampstead,
Hertfordshire**

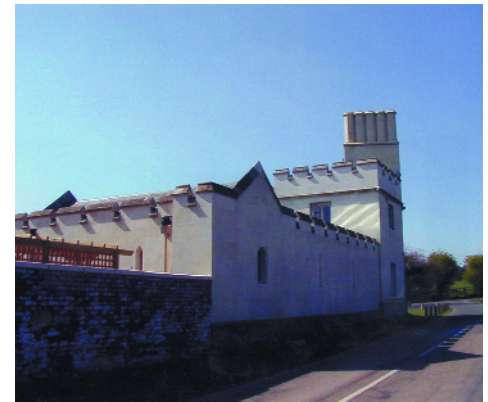
This gatehouse to a large country manor was built of local clunch, which is not known for its weathering. Restoration contains a balance between piecing in of new stone and the usual spinning back of the face to sound surface. A solution which suits clunch.

The string courses, parapets and coping stones had been replaced in Portland stone during an earlier restoration project and the remaining Totternhoe was badly perished.

There was rendering on some areas, which was cracking and falling off.

Rusted iron cramps had caused a significant part of the damage. They were replaced with stainless steel cramps.

All the ashlar to the building had to be replaced, using new Totternhoe stone treated on four sides with a mixture of linseed oil and turpentine when fixing.

The original course heights were maintained with 3mm joints. Half the window surrounds also needed

replacing.

Original chimney stacks were missing and archive photographs were used to design and construct new ones using Stoke Ground Bath Stone, which it was felt would be more durable than the clunch.
